FLIR infrared cameras help to ensure safety at sea

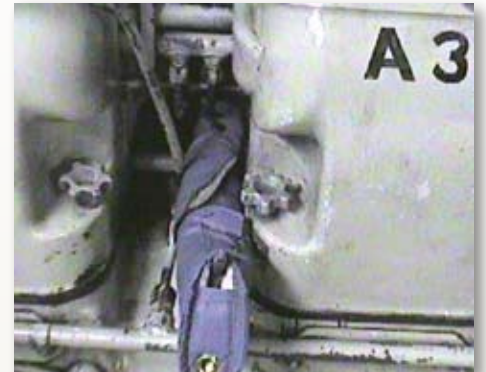
Visual and infrared image of a diesel generator.

During a VTIS survey an exhaust sensing line of a diesel generator showed a temperature in excess of that permitted under SOLAS Regulations. Subsequent investigation found the insulation around the line had perished. Left undetected, the line would have undoubtedly ruptured, causing fuel to spray onto the diesel generator exhaust sensor. If this had in turn ignited, a major fire in the engine room would have resulted. Aside from the safety issues, a high capital cost would also have been incurred in replacing the affected plant and associated engine room equipment.

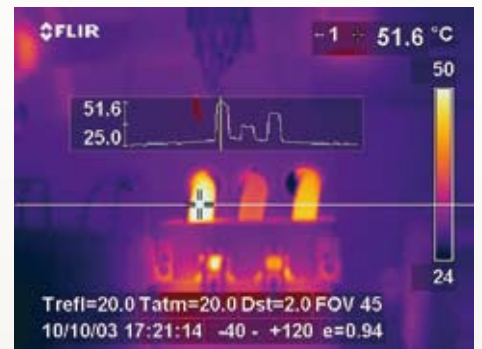
Infrared image of an isolator inspection
